GENERALIZED MONITORING OF SEASCAPE® INSTALLATION AT CAPE HATTERAS LIGHTHOUSE, NORTH CAROLINA

J. W. Forman

US Army Engineer District, Wilmington
PO Box 1890
Wilmington, North Carolina 28402-1890

February 1986
Final Report

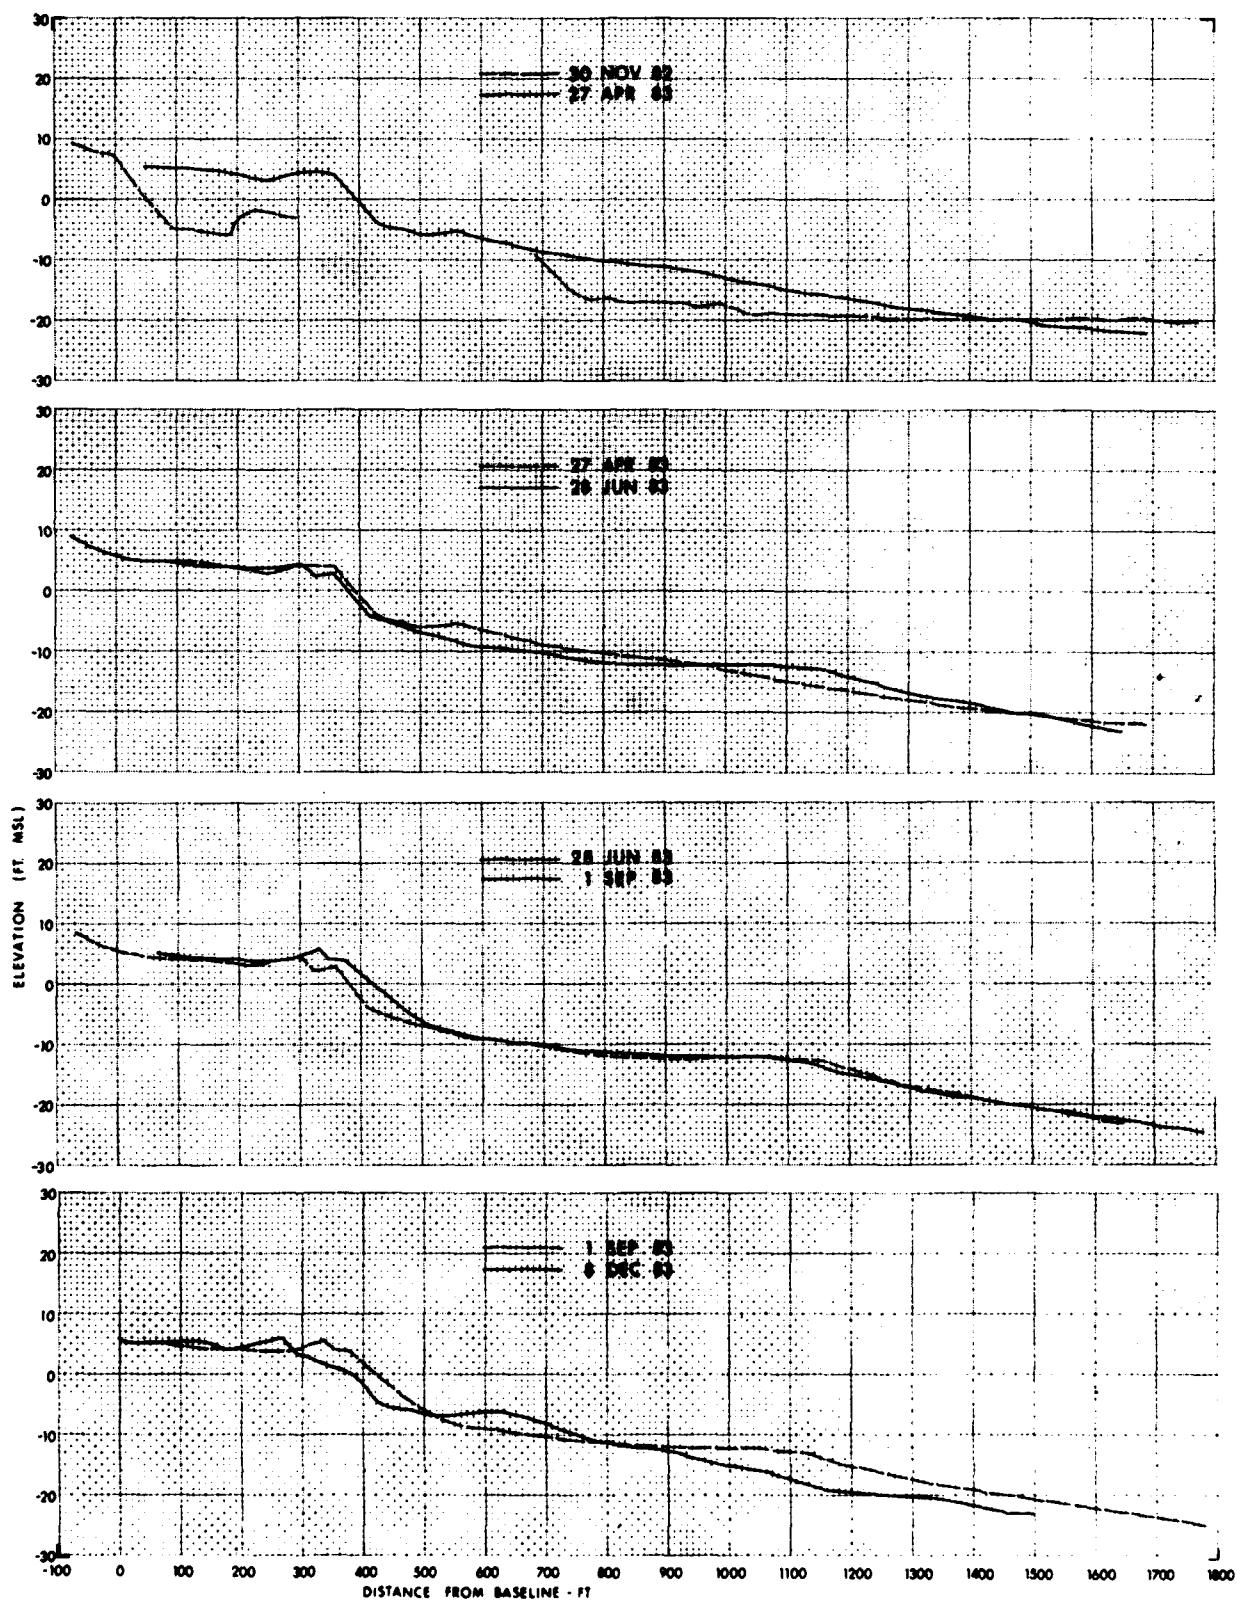
STATION 20+03

Examination of figures 20 through 24, the time series of plots for each beach profile, shows that the northern profiles, stations 10+00, 20+03, and 35+19, act somewhat opposite to the southerly profiles, stations 50+56 and 60+81. Between November 1982 and April 1983, surveys at stations 10+00, 20+03, and 35+19 showed significant accretion of the foreshore and berm portions of the profiles. During the same period, surveys at stations 50+56

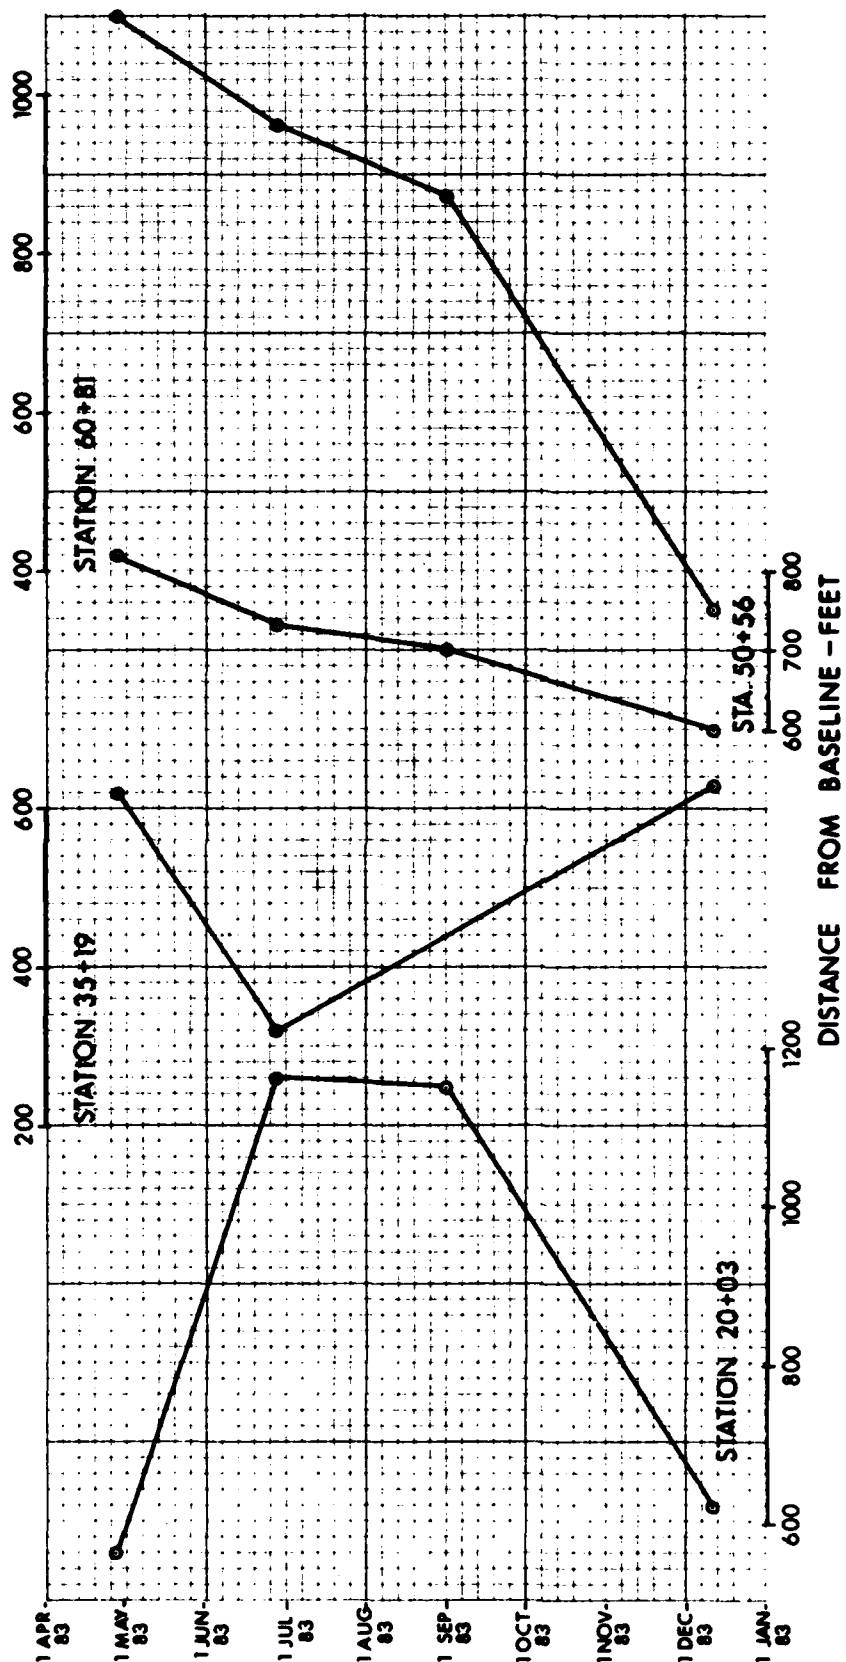
FIGURE 24

The period from September to December 1973 was the period of the greatest change in profile form over the study area. Again, the northern half of the study area exhibited behavior opposite to the southern profiles. The surveys for Stations 10+00, 20+03, and 35+19 all show berm and foreshore erosion accompanied by bar formation close to shore and loss of material from the offshore zone during the September through December period. At station 50+56 there is significant buildup of the berm and foreshore portions of the profile accompanied by loss of material from the offshore zone. At station 60+81, significant filling of the foreshore resulting in gains in elevation of over 12 feet at a point 500 feet from the baseline (see figure 24) is accompanied by losses of material from the berm and offshore zones.

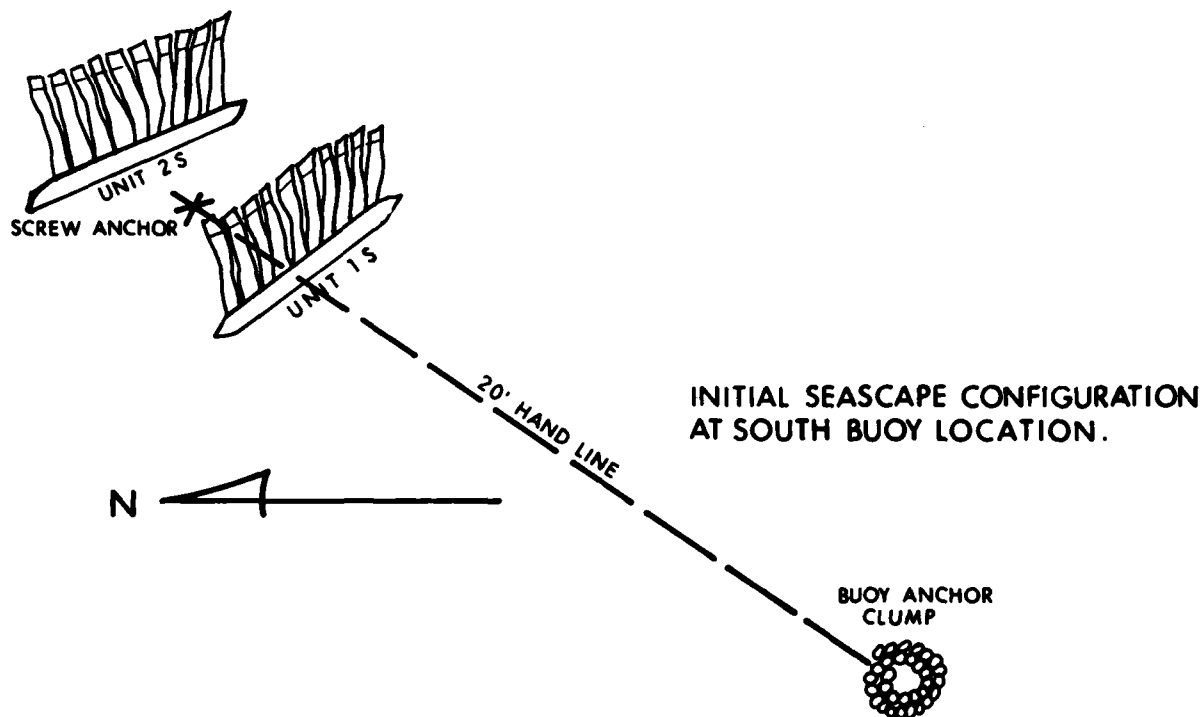
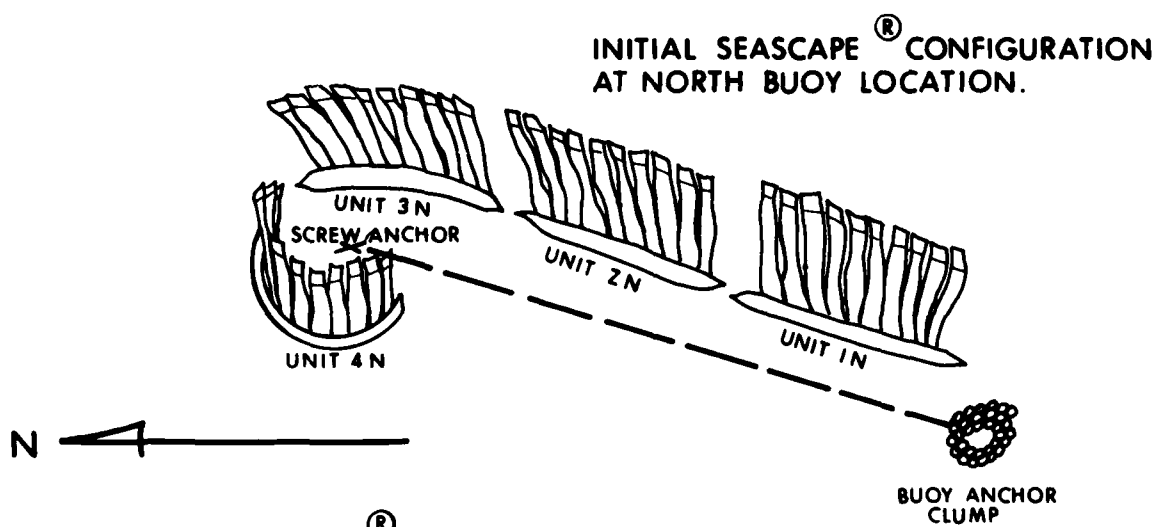
FIGURE 26

SEASCAPE CONFIGURATIONS AT NORTH AND SOUTH BUOY LOCATIONS

North Buoy Observations: A group of four SEASCAPE® units was in place along the hand line from the buoy anchor to the screw anchor (see figure 26). Limited visibility prevented divers from observing the anchor tube sections of the units; however, divers did observe that the bags were approximately half exposed and the fronds were free and untangled. A spot dive about 20 feet inshore of the north buoy location revealed SEASCAPE® units with only 6 inches of fronds exposed. No attempt was made to determine if the fronds were buried in a vertical position. Most of the material in the anchor tubes was located at one end, leaving 25% of the tube without material.
